**LAB ANALYSIS REPORT**

<b>Company:</b>	<b>Date:</b> March 8, 2012
<b>Submitted by:</b> [Redacted]	<b>Report No.:</b> 12-0119
<b>Ph.</b>	<b>P. O. No.:</b> <b>Page 1 of 10</b>

**Vendor:** Micron Technologies / Reballer - Corfin  
**Part Number:** Original 00085948F / Reballer 049999D-00  
**Description:** VFBGA90 - DDR 32Mx16  
**Quantity Received:** 3  
**Request No.:** MILA 851

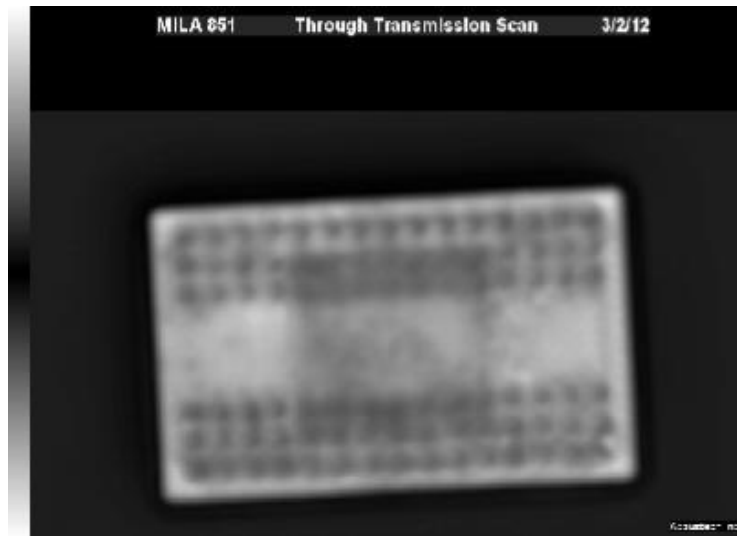
**Figure 1**

Curve tracer analysis finds no opens or shorts and the junction characteristics are normal. Sonoscan testing found no evidence of delamination on any of the parts. See Figures 1 – 6.

**Re-balled 1 – TS Scan**

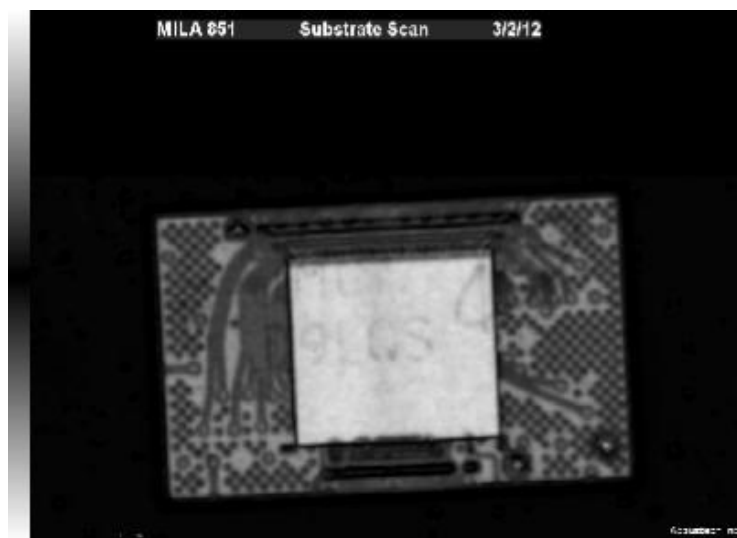
**Figure 2**

**Re-balled 1 Substrate**

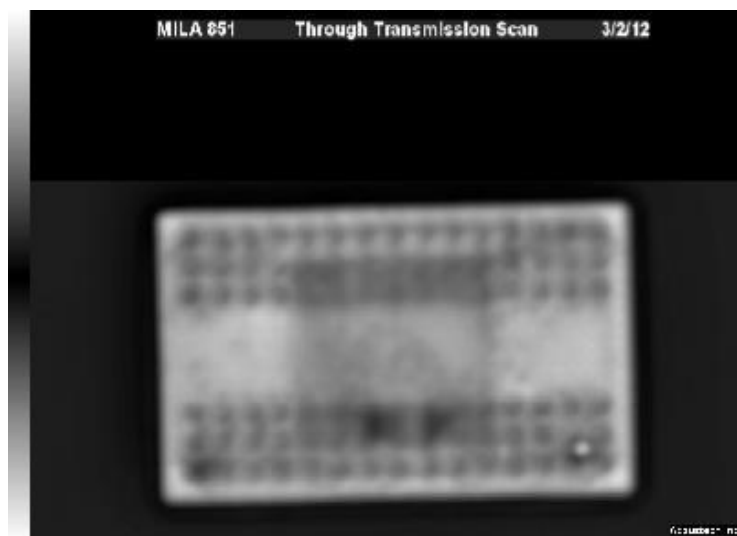
**Figure 3**

**Re-balled 2 – TS Scan**

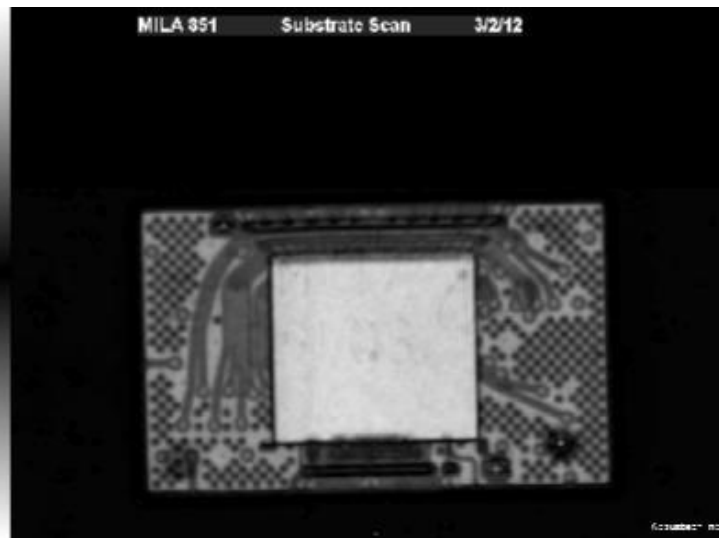
**Figure 4**

**Re-balled 2 – Substrate**

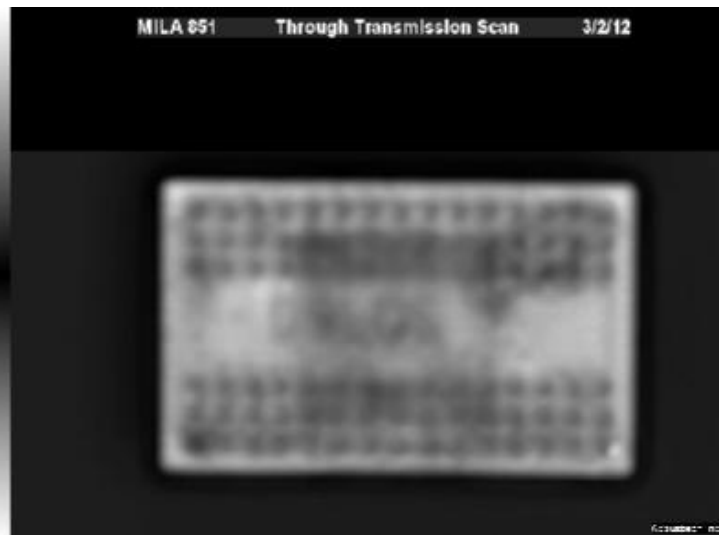
**Figure 5**

**Re-balled 3 TS Scan**

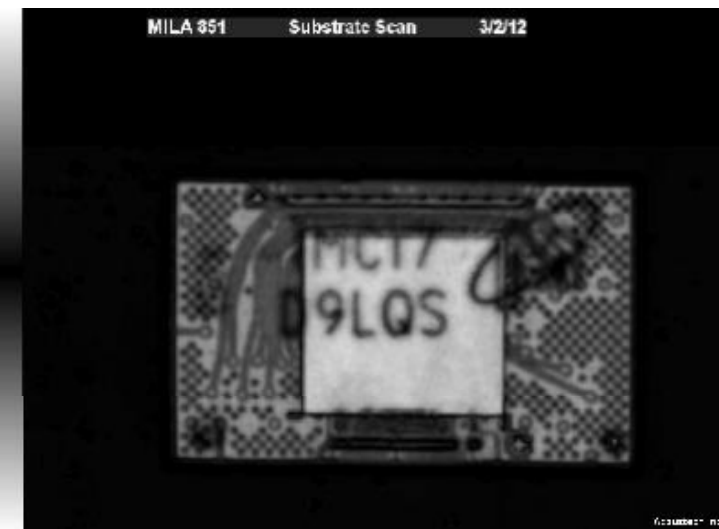
**Figure 6**

**Re-balled 3 – Substrate**

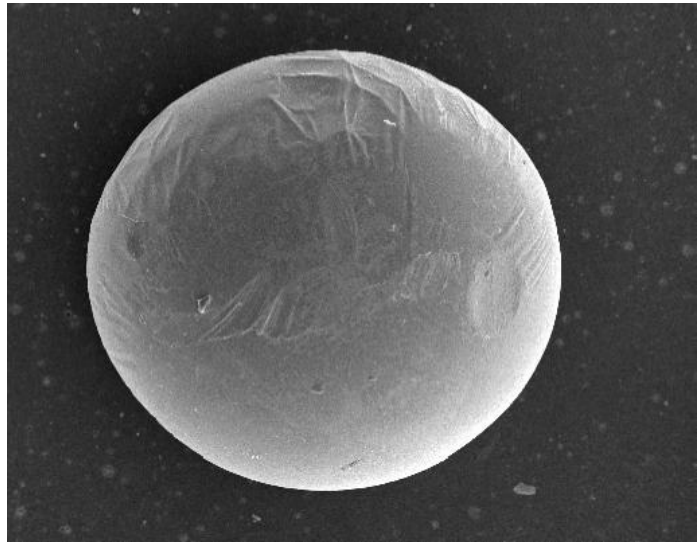
**Figure 7**

SEM images were collected of a typical ball from each sample. See Figures 7 – 9.

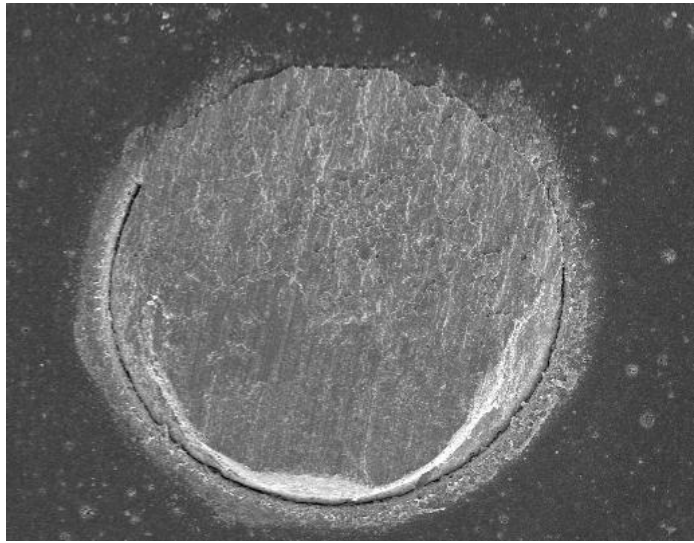
**Figure 10**

SEM inspection of the sheared device pads finds that all the samples appear to be ductile separations. See Figures 10 – 21.

**Typical Sheared Pad**

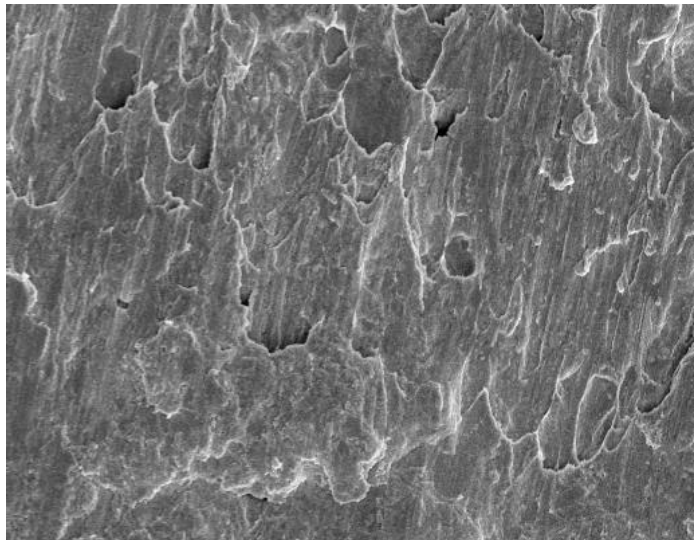
**Figure 11**

**Typical Sheared Pad**

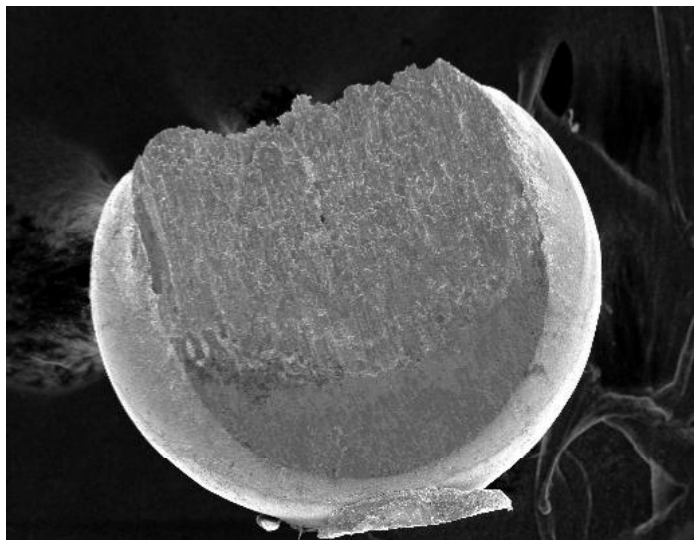
**Figure 12**

**Typical Sheared Ball**

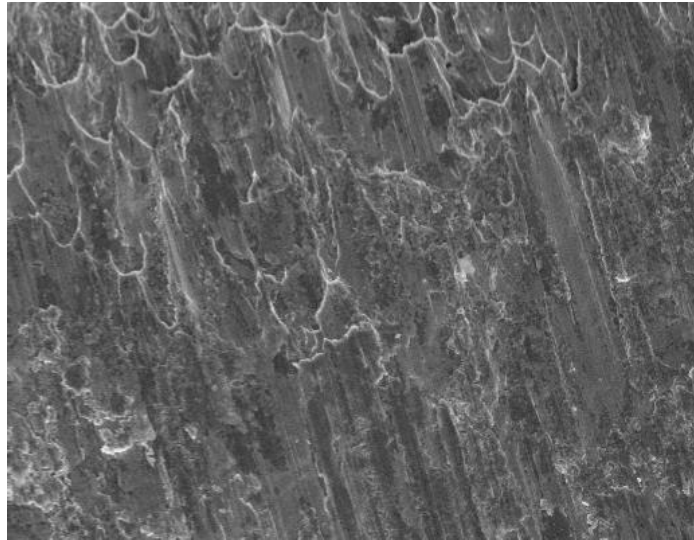
**Figure 13**

**Typical Sheared Ball**

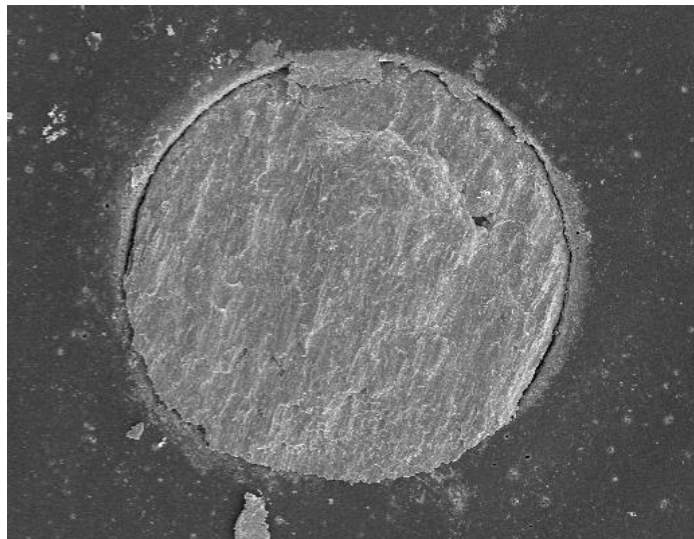
**Figure 14**

**Typical Sheared Pad**

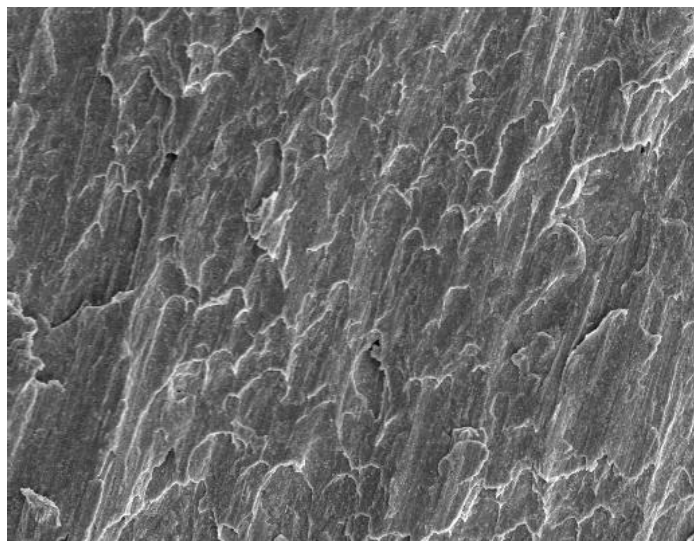
**Figure 15**

**Typical Sheared Pad**

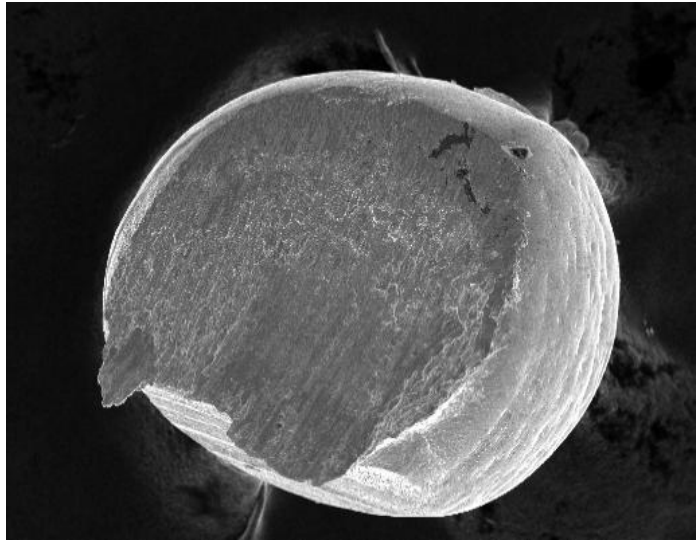
**Figure 16**  
**Re-balled - 2**  
**Typical Sheared Ball**  
**160X**

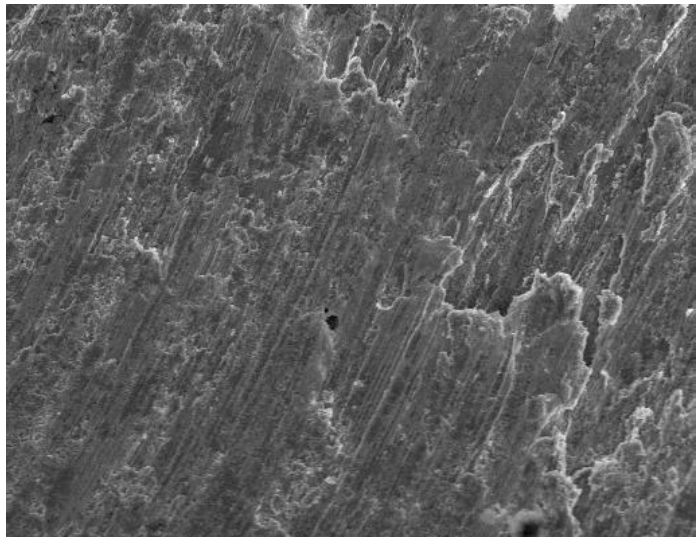
**Figure 17**  
**Re-balled - 2**  
**Typical Sheared Ball**  
**1KX**

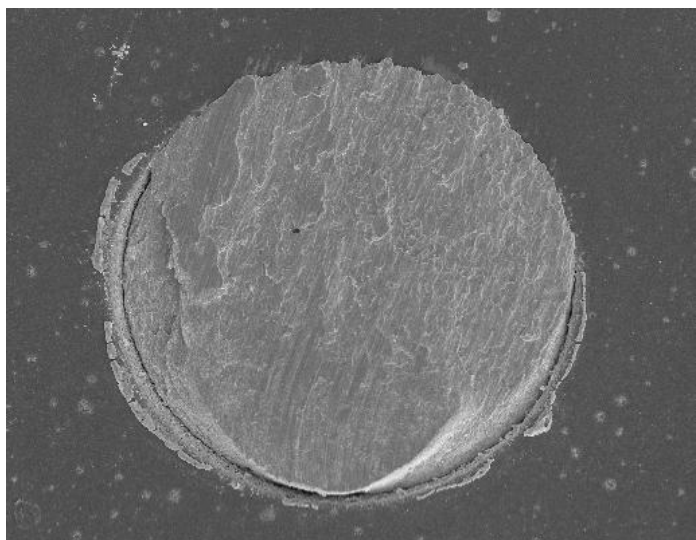
**Figure 18**  
**Re-balled - 3**  
**Typical Sheared Pad**  
**180X**

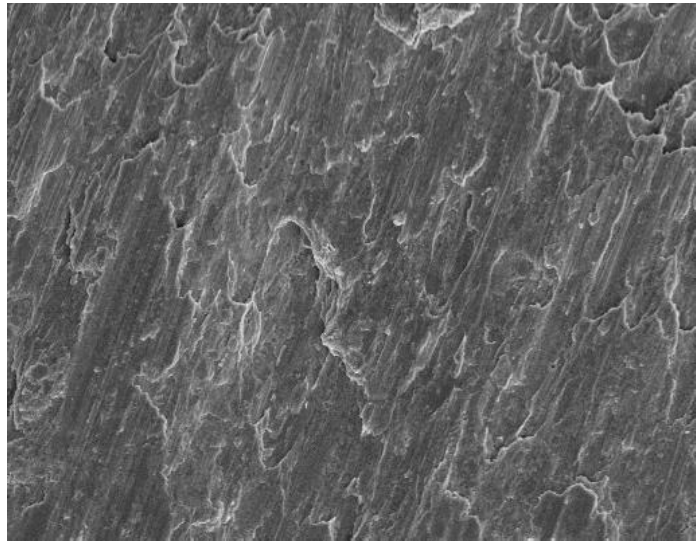
**Figure 19**

**Typical Sheared Pad**

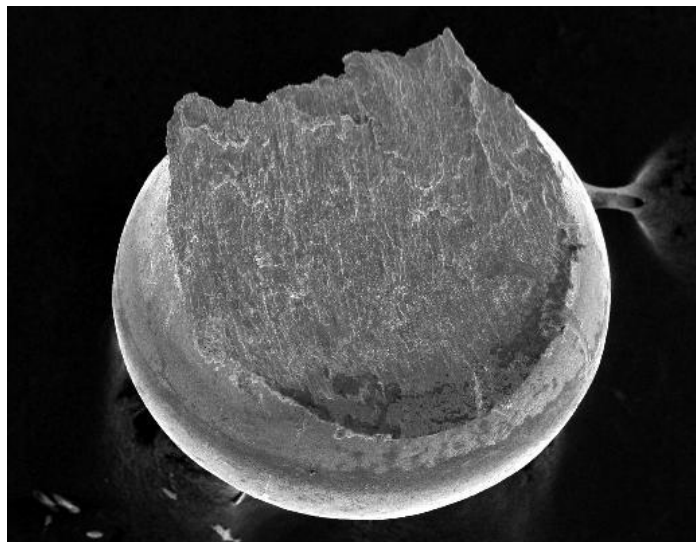
**Figure 20**

**Typical Sheared Ball**

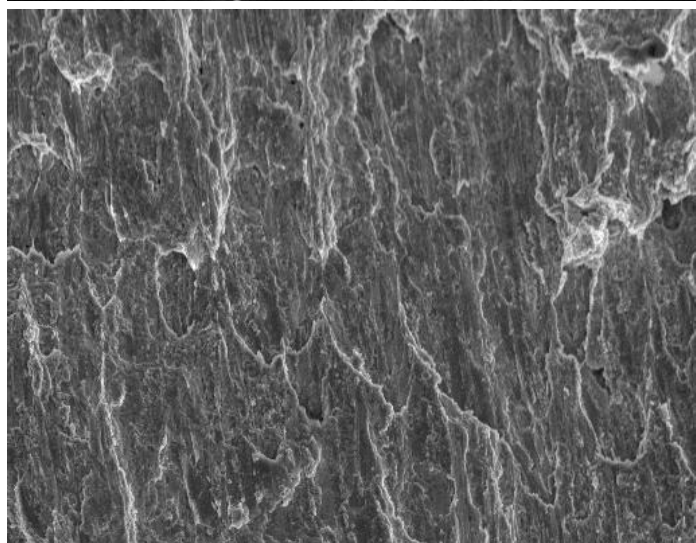
**Figure 21**

**Typical Sheared Ball**

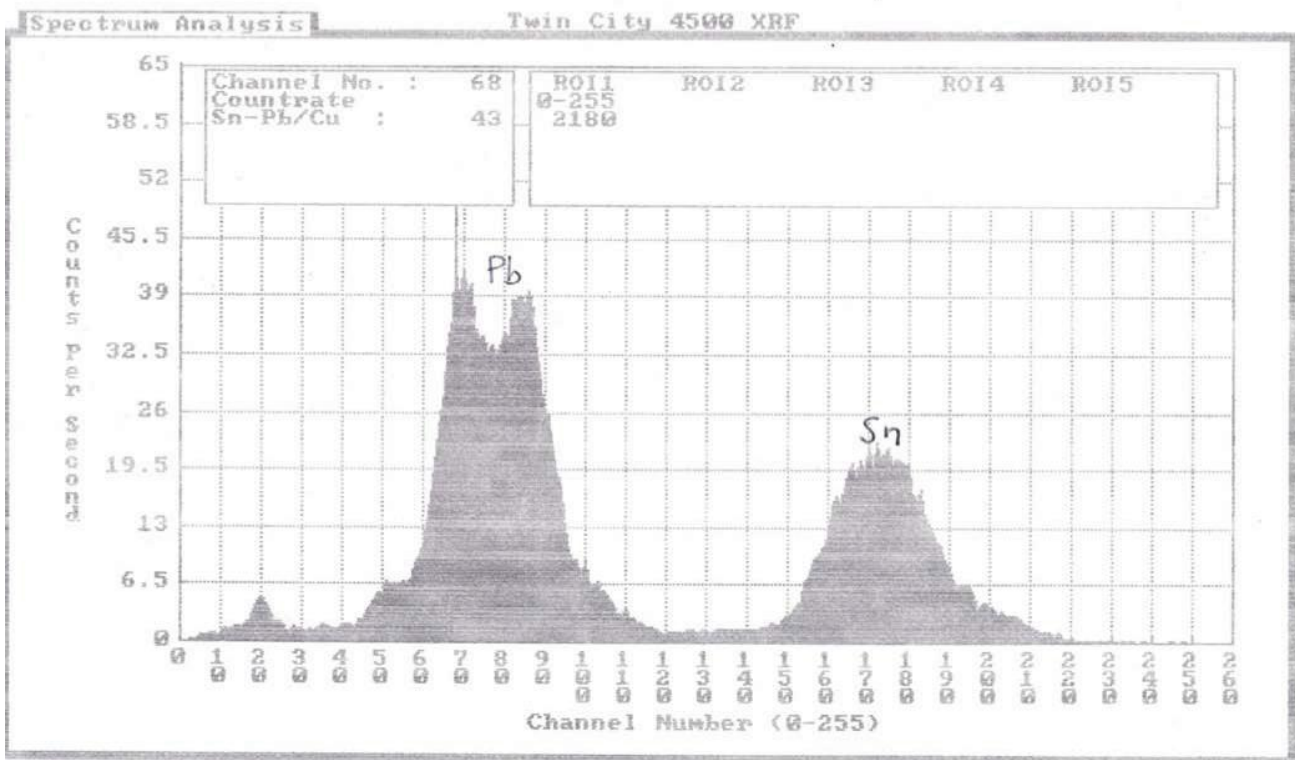
Figure 22

XRF analysis finds that the re-balled ball contains lead (Pb). See Figure 22.
