**LAB ANALYSIS REPORT**

<b>Company:</b>	<b>Date:</b> March 8, 2012
<b>Submitted by:</b> [Redacted]	<b>Report No.:</b> 12-0120A
<b>Ph.</b>	<b>P. O. No.:</b>
	<b>Page 1 of 12</b>

**Vendor:** Micron Technologies / Reballer - Corfin  
**Part Number:** 00062608F / Reballer – 049999F-00  
**Description:** VFBGA90 – SDRAM 8Mx32 7.5ms  
**Quantity Received:** 3  
**Request No.:** MILA 852

Three devices have been re-balled. Perform Sonoscan analysis for delamination or other defects. Perform ball shear testing and SEM of sheared pads to characterize the separation(s). Perform electrical test at R/T and XRF to verify ball composition.

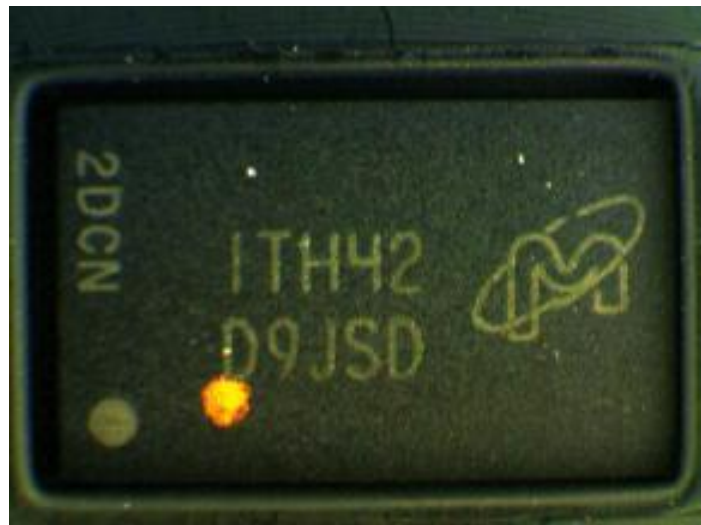
**Figure 1**

**Package Markings**

**All devices have the same markings**

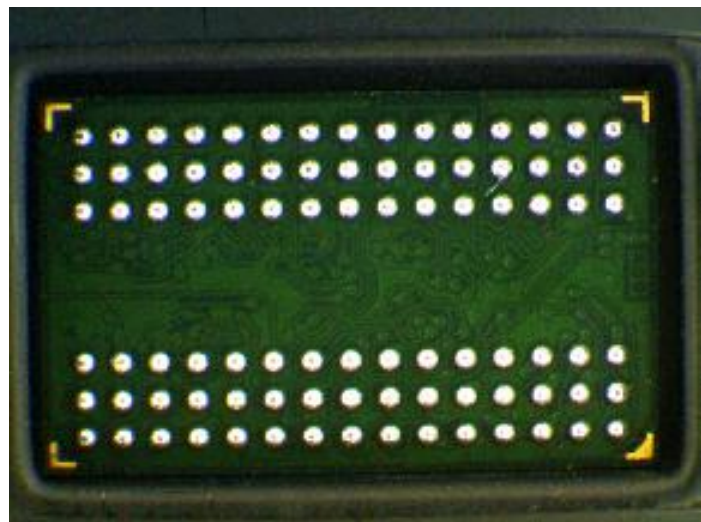
**Figure 2**

**Package BGA Side**

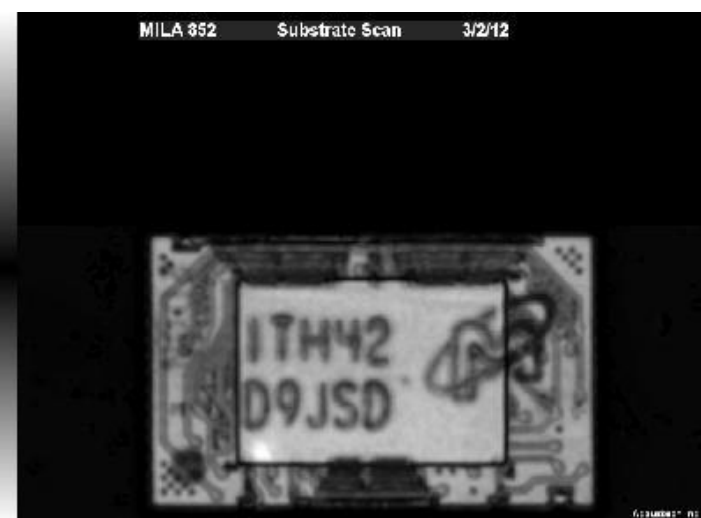
**Figure 3**

Sonoscan testing found no evidence of delamination, cracking or other defects. See Figures 1 – 8.

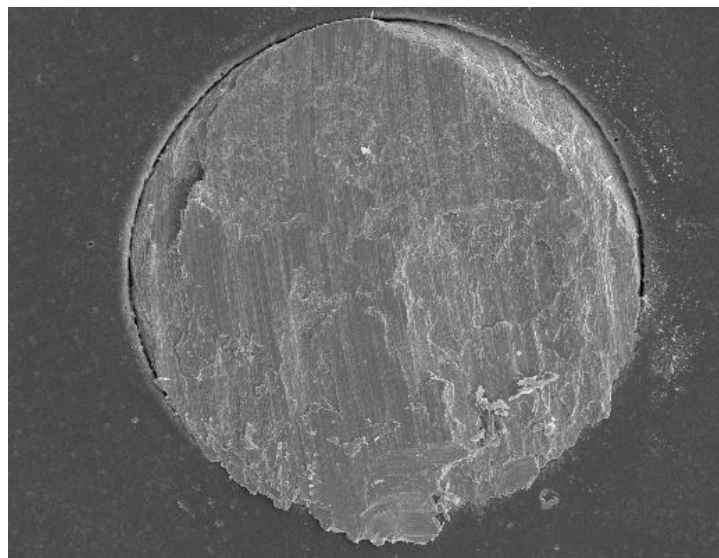
**Figure 9**  
**Red Dot 1**  
**Inner Row**  
**200X**

SEM inspection of the sheared device pads and balls finds that all appear to be ductile separations and there were no apparent differences between inner and outer rows. See Figures 9 – 29.

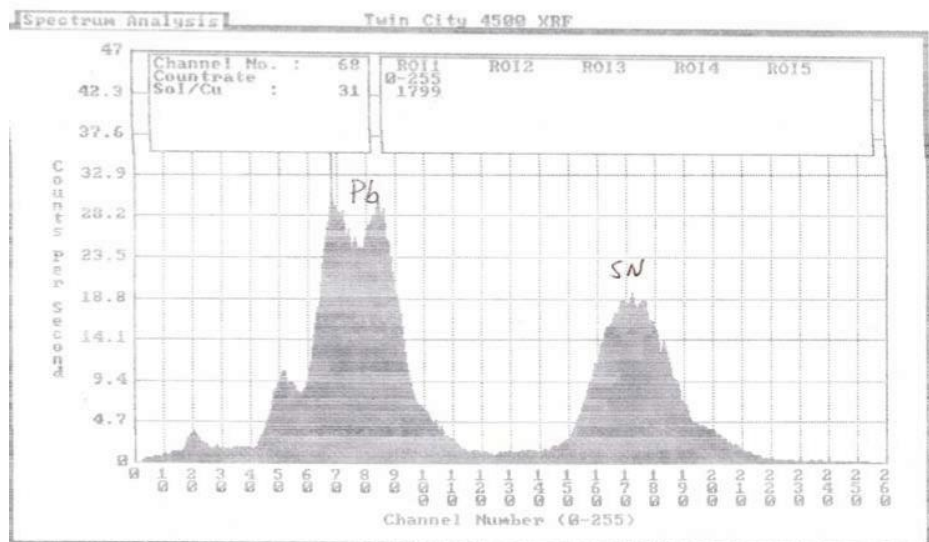
**Figure 30**  
**XRF of Typical Ball**

Curve tracer analysis finds no opens or shorts and the junction characteristics are normal. XRF analysis finds that the re-balled ball contains lead (Pb). See Figure 30.
